# FIELD INSPECTION REPORT

<b>Project Name:</b>	Mountain Valley Pipeline	<b>Inspector:</b>	Matthew Grant
<b>Inspection Date:</b>	Wednesday, January 27, 2021	<b>Project Contact:</b>	Brian Clauto
<b>Spread H: Montgomery</b>	ST12010-12040 ATWS1160, 1159, 1161 AR-MN268	<b>Weather:</b>	Wet

# FIELD INSPECTION PHOTO LOG

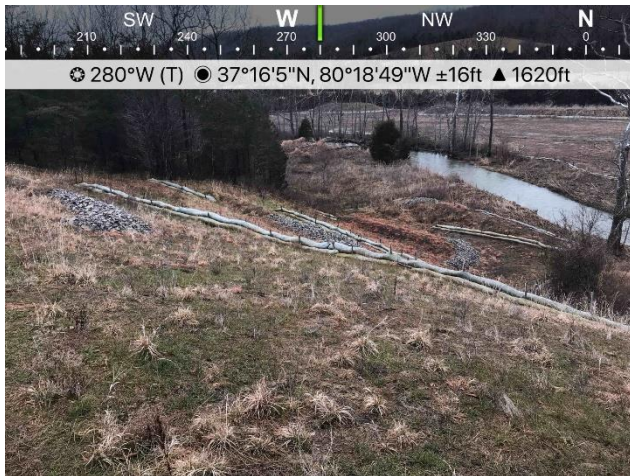
- Figure 1: Near MP227.3, permanent and temporary waterbars are in place and functioning.

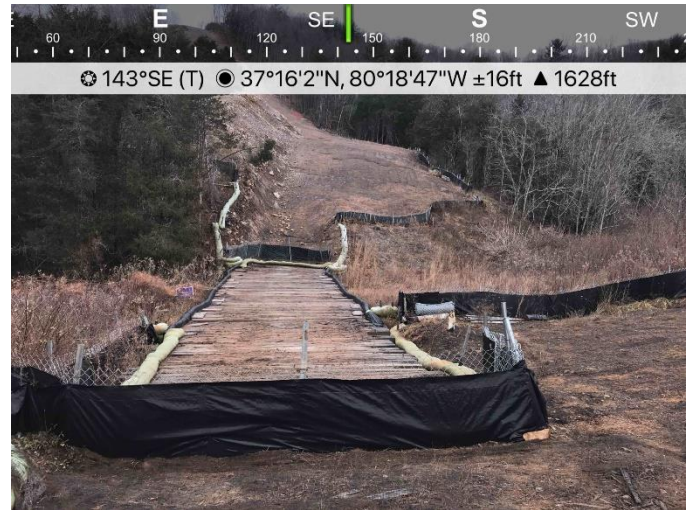
- Figure 2: Designated stream crossing S-G38 ECD's are in place and functioning.

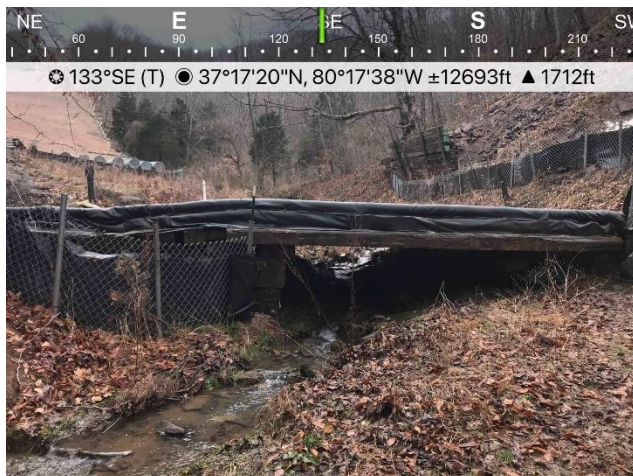
- Figure 3: Designated stream crossing S-G40 ECD's are in place and functioning.

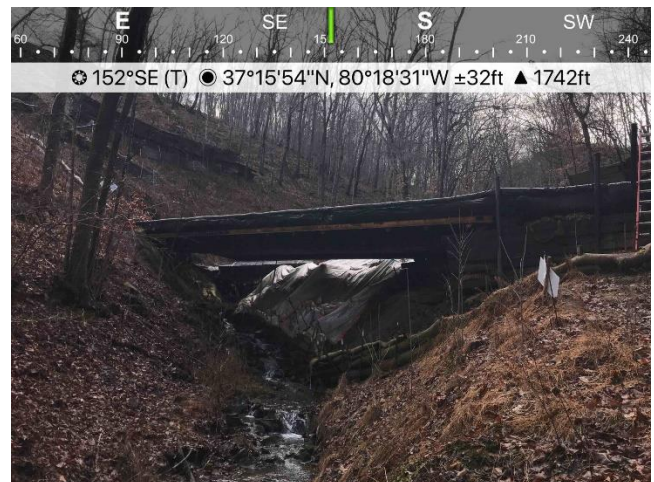
- Figure 4: Designated stream crossing S-G39 ECD's are in place and functioning.
